Khan al-Wazir

Rapid Damage Assessment | تقييم سريع للأضرار

Alaaeddin Haddad
Issam Ballouz
Rami Alafandi
York Rieffel (consultant)

Date of Report
2020-01-17

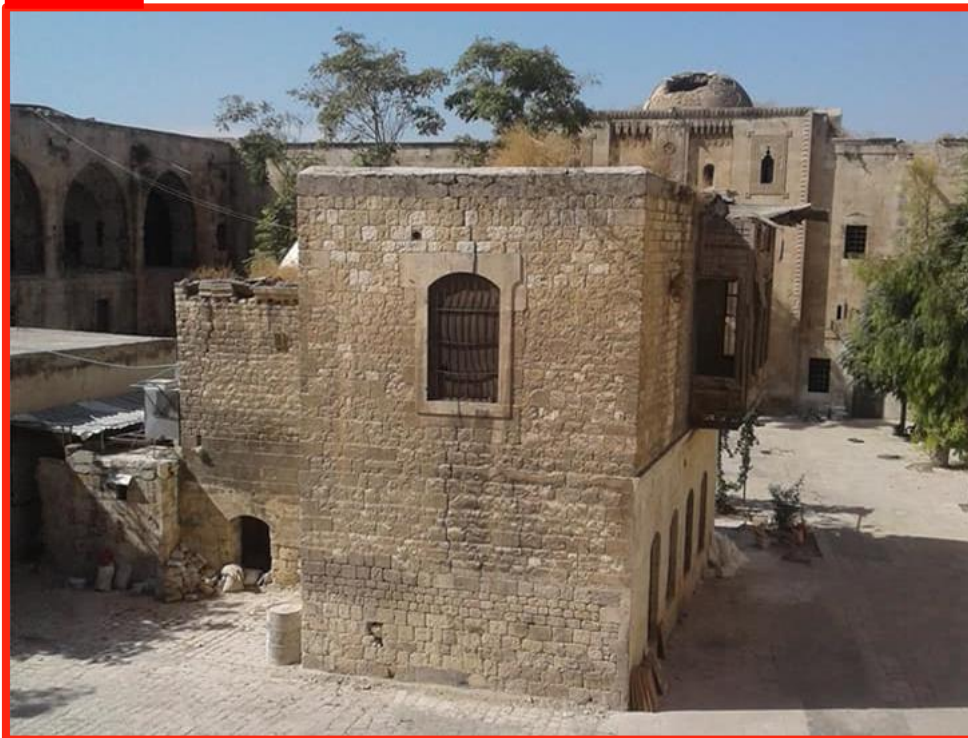
After

Khan al-Wazir after the armed conflict (© Majed Talustan Facebook, December 2019)

It seems that the khan has not incurred structural damages. However, some surface damages were noticed. The dome at the top of the portal gate is partially fallen.

Damaged sections ① The dome of the hall on the upper floor of the gate is partially collapsed.

Risk **Local danger of collapse due to structural damage**

An emergency structural stabilization of the damaged dome is strictly recommended.

Urgent intervention **Safeguarding measures**: emergency structural stabilization of the dome.
Protective measures: protection of exposed masonry against rain.
