Khan al-Wazir

Rapid Damage Assessment | تقييم سريع للأضرار

Alaaeddin Haddad
Issam Ballouz
Rami Alafandi
York Rieffel (consultant)

Date of Report
2020-01-17

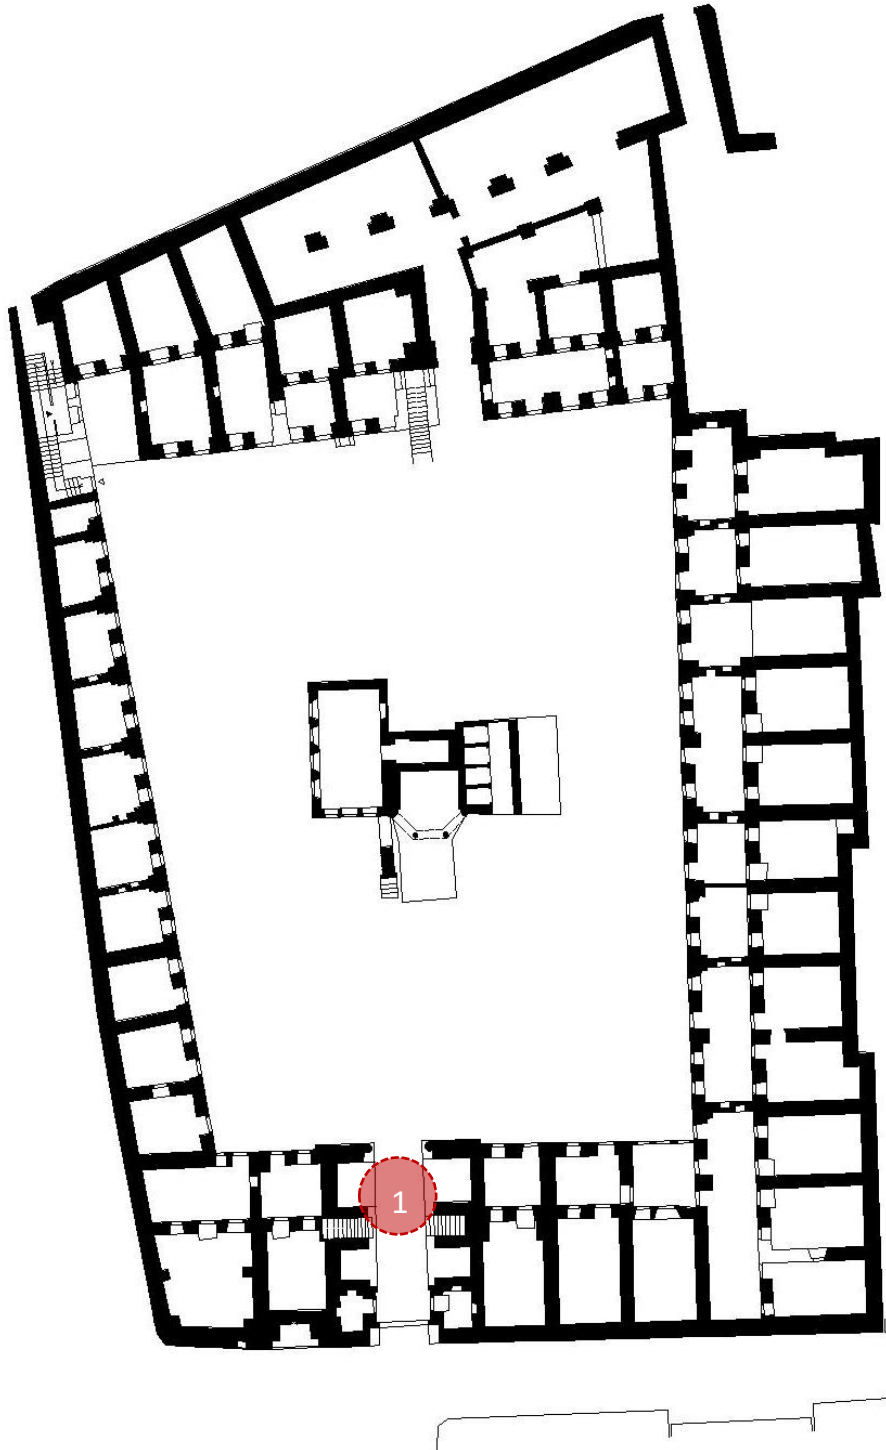
مسقط الطابق الأرضي | Ground floor plan

Damaged sections ① The dome of the hall on the upper floor of the gate is partially collapsed.

Cause of damage Effects of war: impacts by shelling, bullet holes, shrapnel

Kind of damage
Collapse: --
Structural damage: partial damage of a dome
Local damage: loss, voids, loose components, fractures / cracks

Scope of damage General surface damages and part of a dome

Risk **Local danger of collapse due to structural damage**

Further recommended intervention Rebuilding or repair of the dome. Any repairs or rebuilding should be carried out largely with original materials and according to historically transmitted procedures and techniques.
General advice: building documentation. All-round systematic photographic documentation (stadia, photogrammetric, 3D etc.) of the building, the damaged sections including the rubble ([see separate guideline documentation](#)).
Rubble management: keep, safe and store the rubble on site ([see guideline below](#))
